SIMPASTURE PARK FOOTBALL PITCH DRAINAGE

AGENDA ITEM No. 9

MEETING: POLICY & RESOURCES

DATE: 4TH DECEMBER 2024

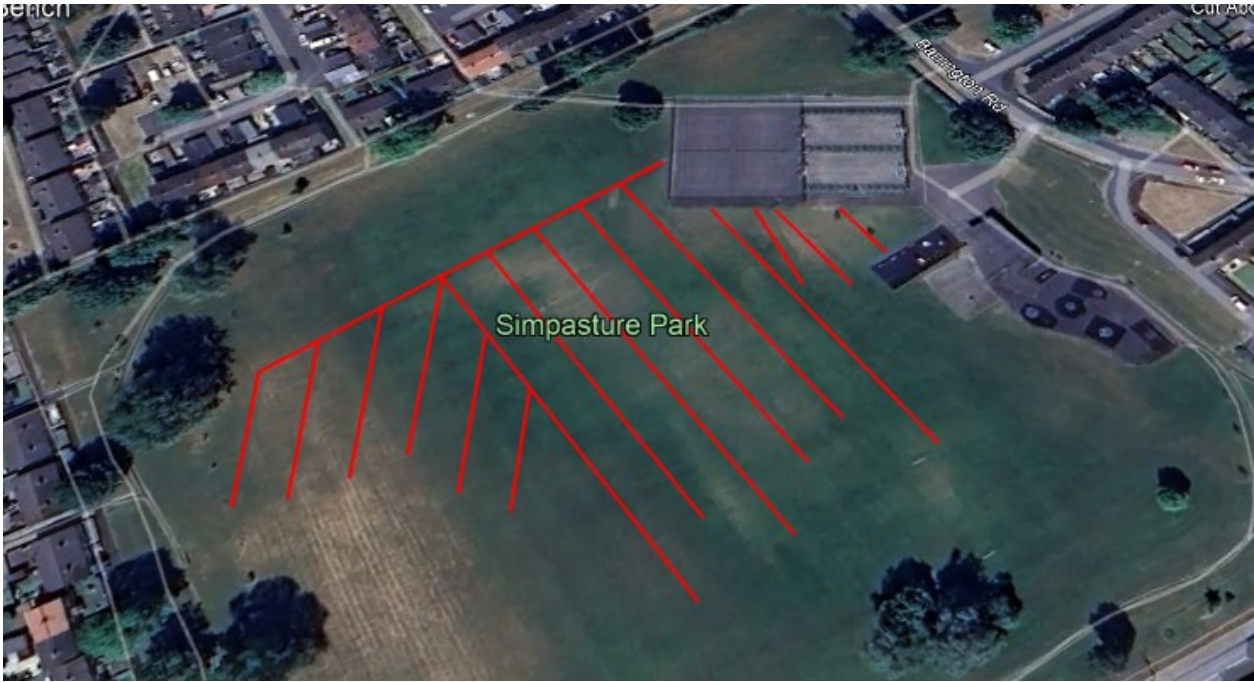
- 3.7 Beyond the MUGA, towards the field, herring bone drainage has been identified from arial photographs showing the course of the original drainage which was probably installed in the 1960's. Please see Appendix 1 for a photograph with the drainage system highlighted.

- 3.8 Contractors were therefore contacted with a specification to replicate the drainage coverage as highlighted in Appendix 1.
- 3.9 The specifications included 1,000 metres of trench, 250/300mm wide, to a maximum of 450mm depth following the natural fall of the land, inserting a 25/85 diameter drainage pipe, and back filling with 30/40mm gravel and relaying the turf.
